## **OCEANA NAVAL AIR STATION**

**Corrosion Control Hangar portion of FA/18 BRAC relocation project**

**Overall accident view for fall which occurred during a repositioning operation to steel joists of lower roof section 3 Feb 99.**

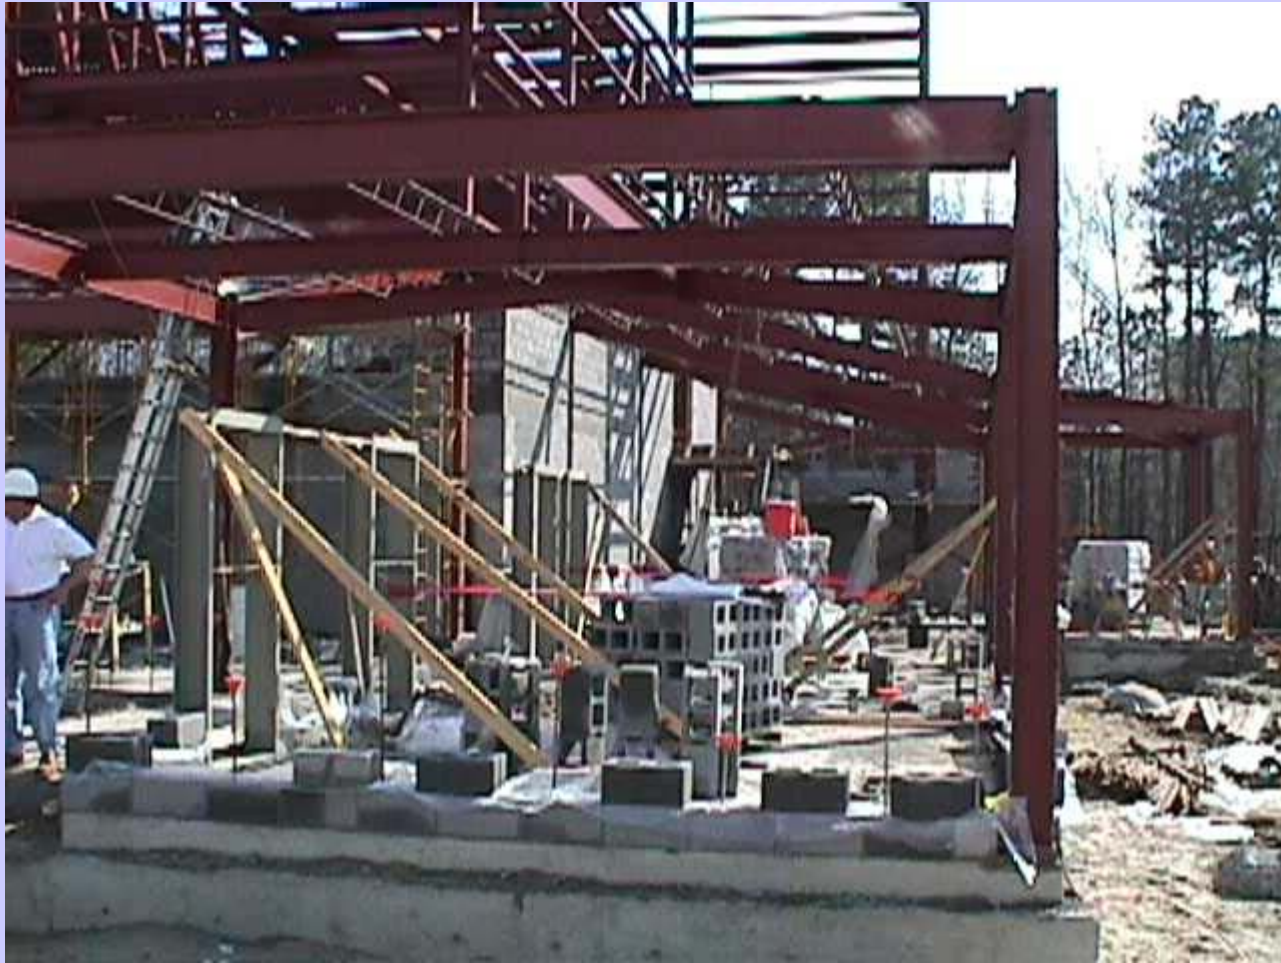
**Steel erection worker/welder was reattaching joists for rework in this area when he fell approximately 12 feet**

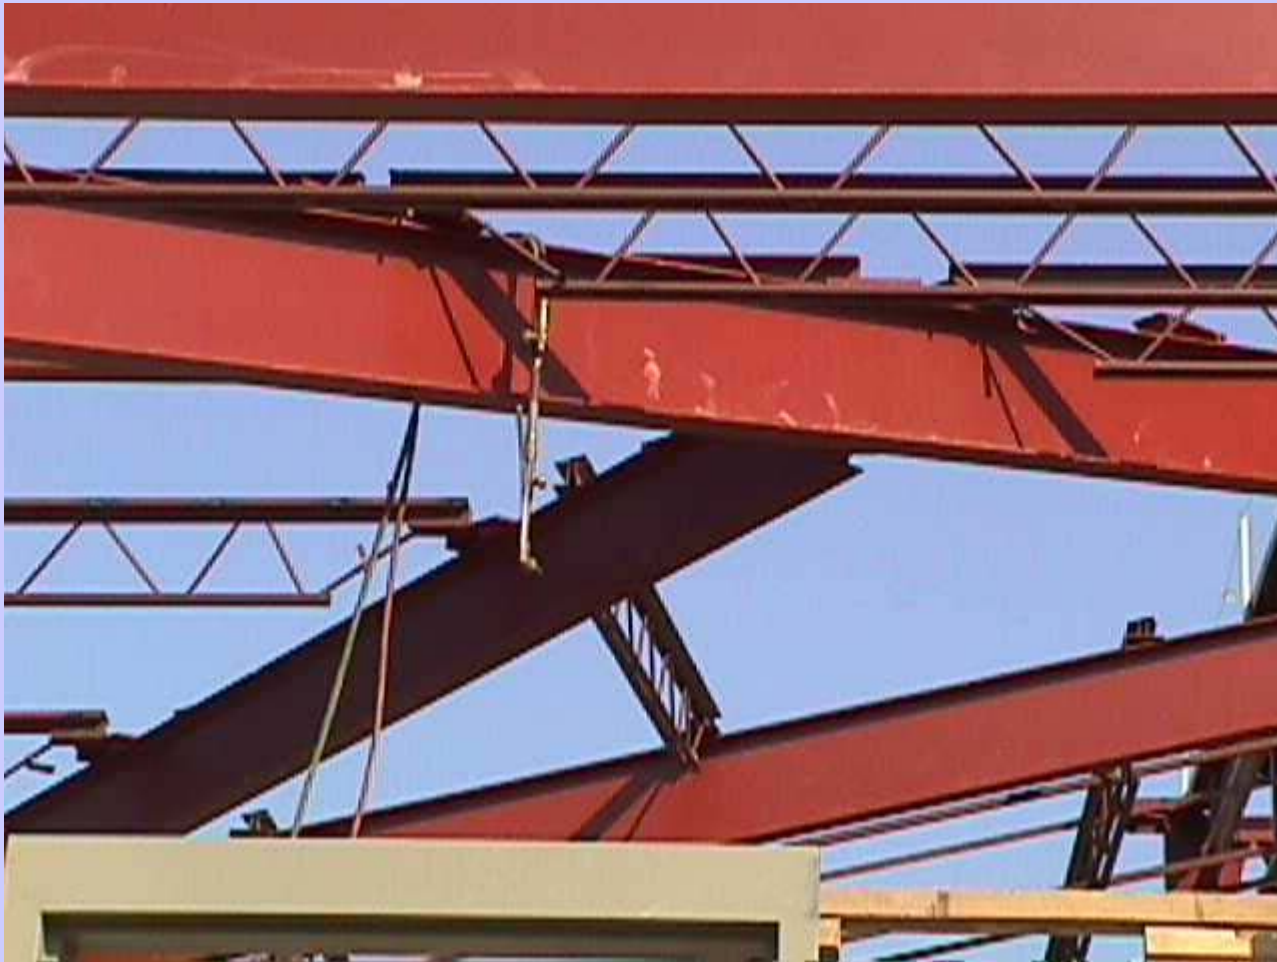
**Witness summary indicates worker was welding at this location**

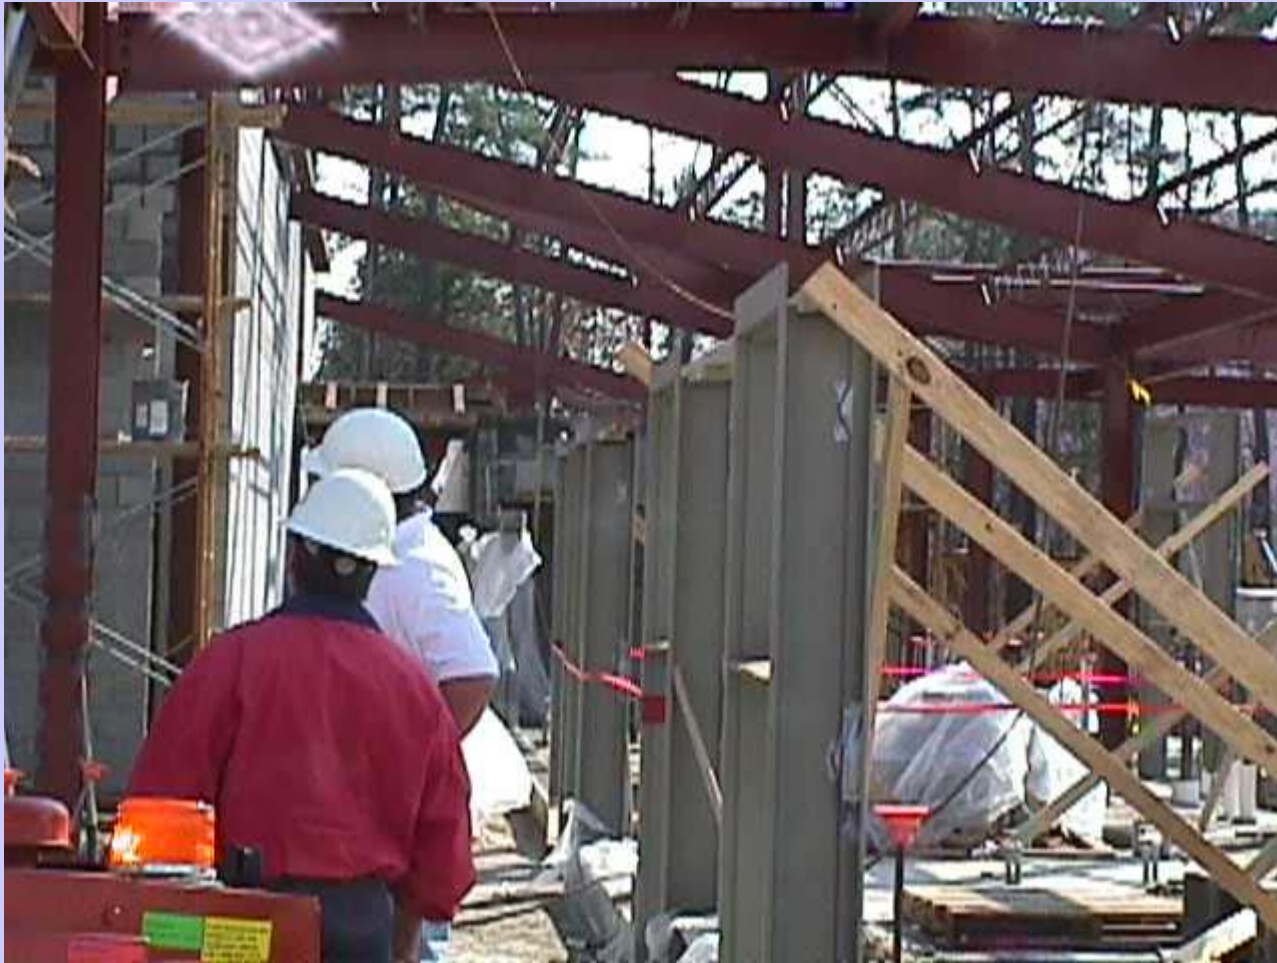
- During fall the worker struck the top of this door frame with his lower torso

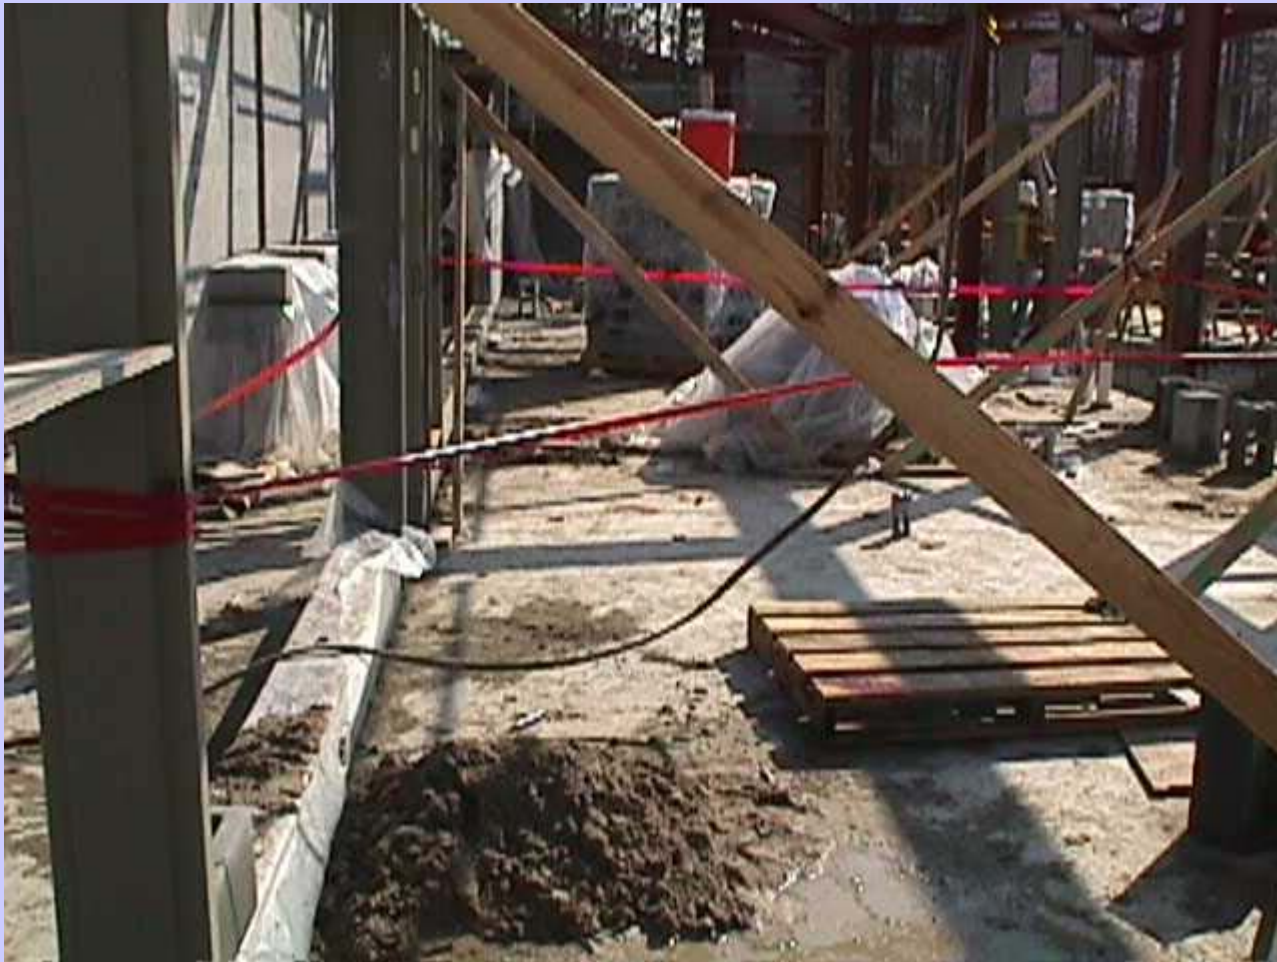
- The worker then fell on this pallet causing a gash to the front head area
